MARINE ATTACK SQUADRON 251
MARINE AIRCRAFT GROUP 15
Aircraft, Fleet Marine Force, Pacific
Marine Corps Air Station
El Toro (Santa Ana), California

T Y P E " B " R E P O R T (C O M M A N D D I A R Y)
PERIOD OF 1 APRIL THROUGH 30 APRIL 1952

FIRST ENDORSEMENT on VMA-251 Aircraft Accident Report 2-52

Subj: Aircraft Accident Report 2-52

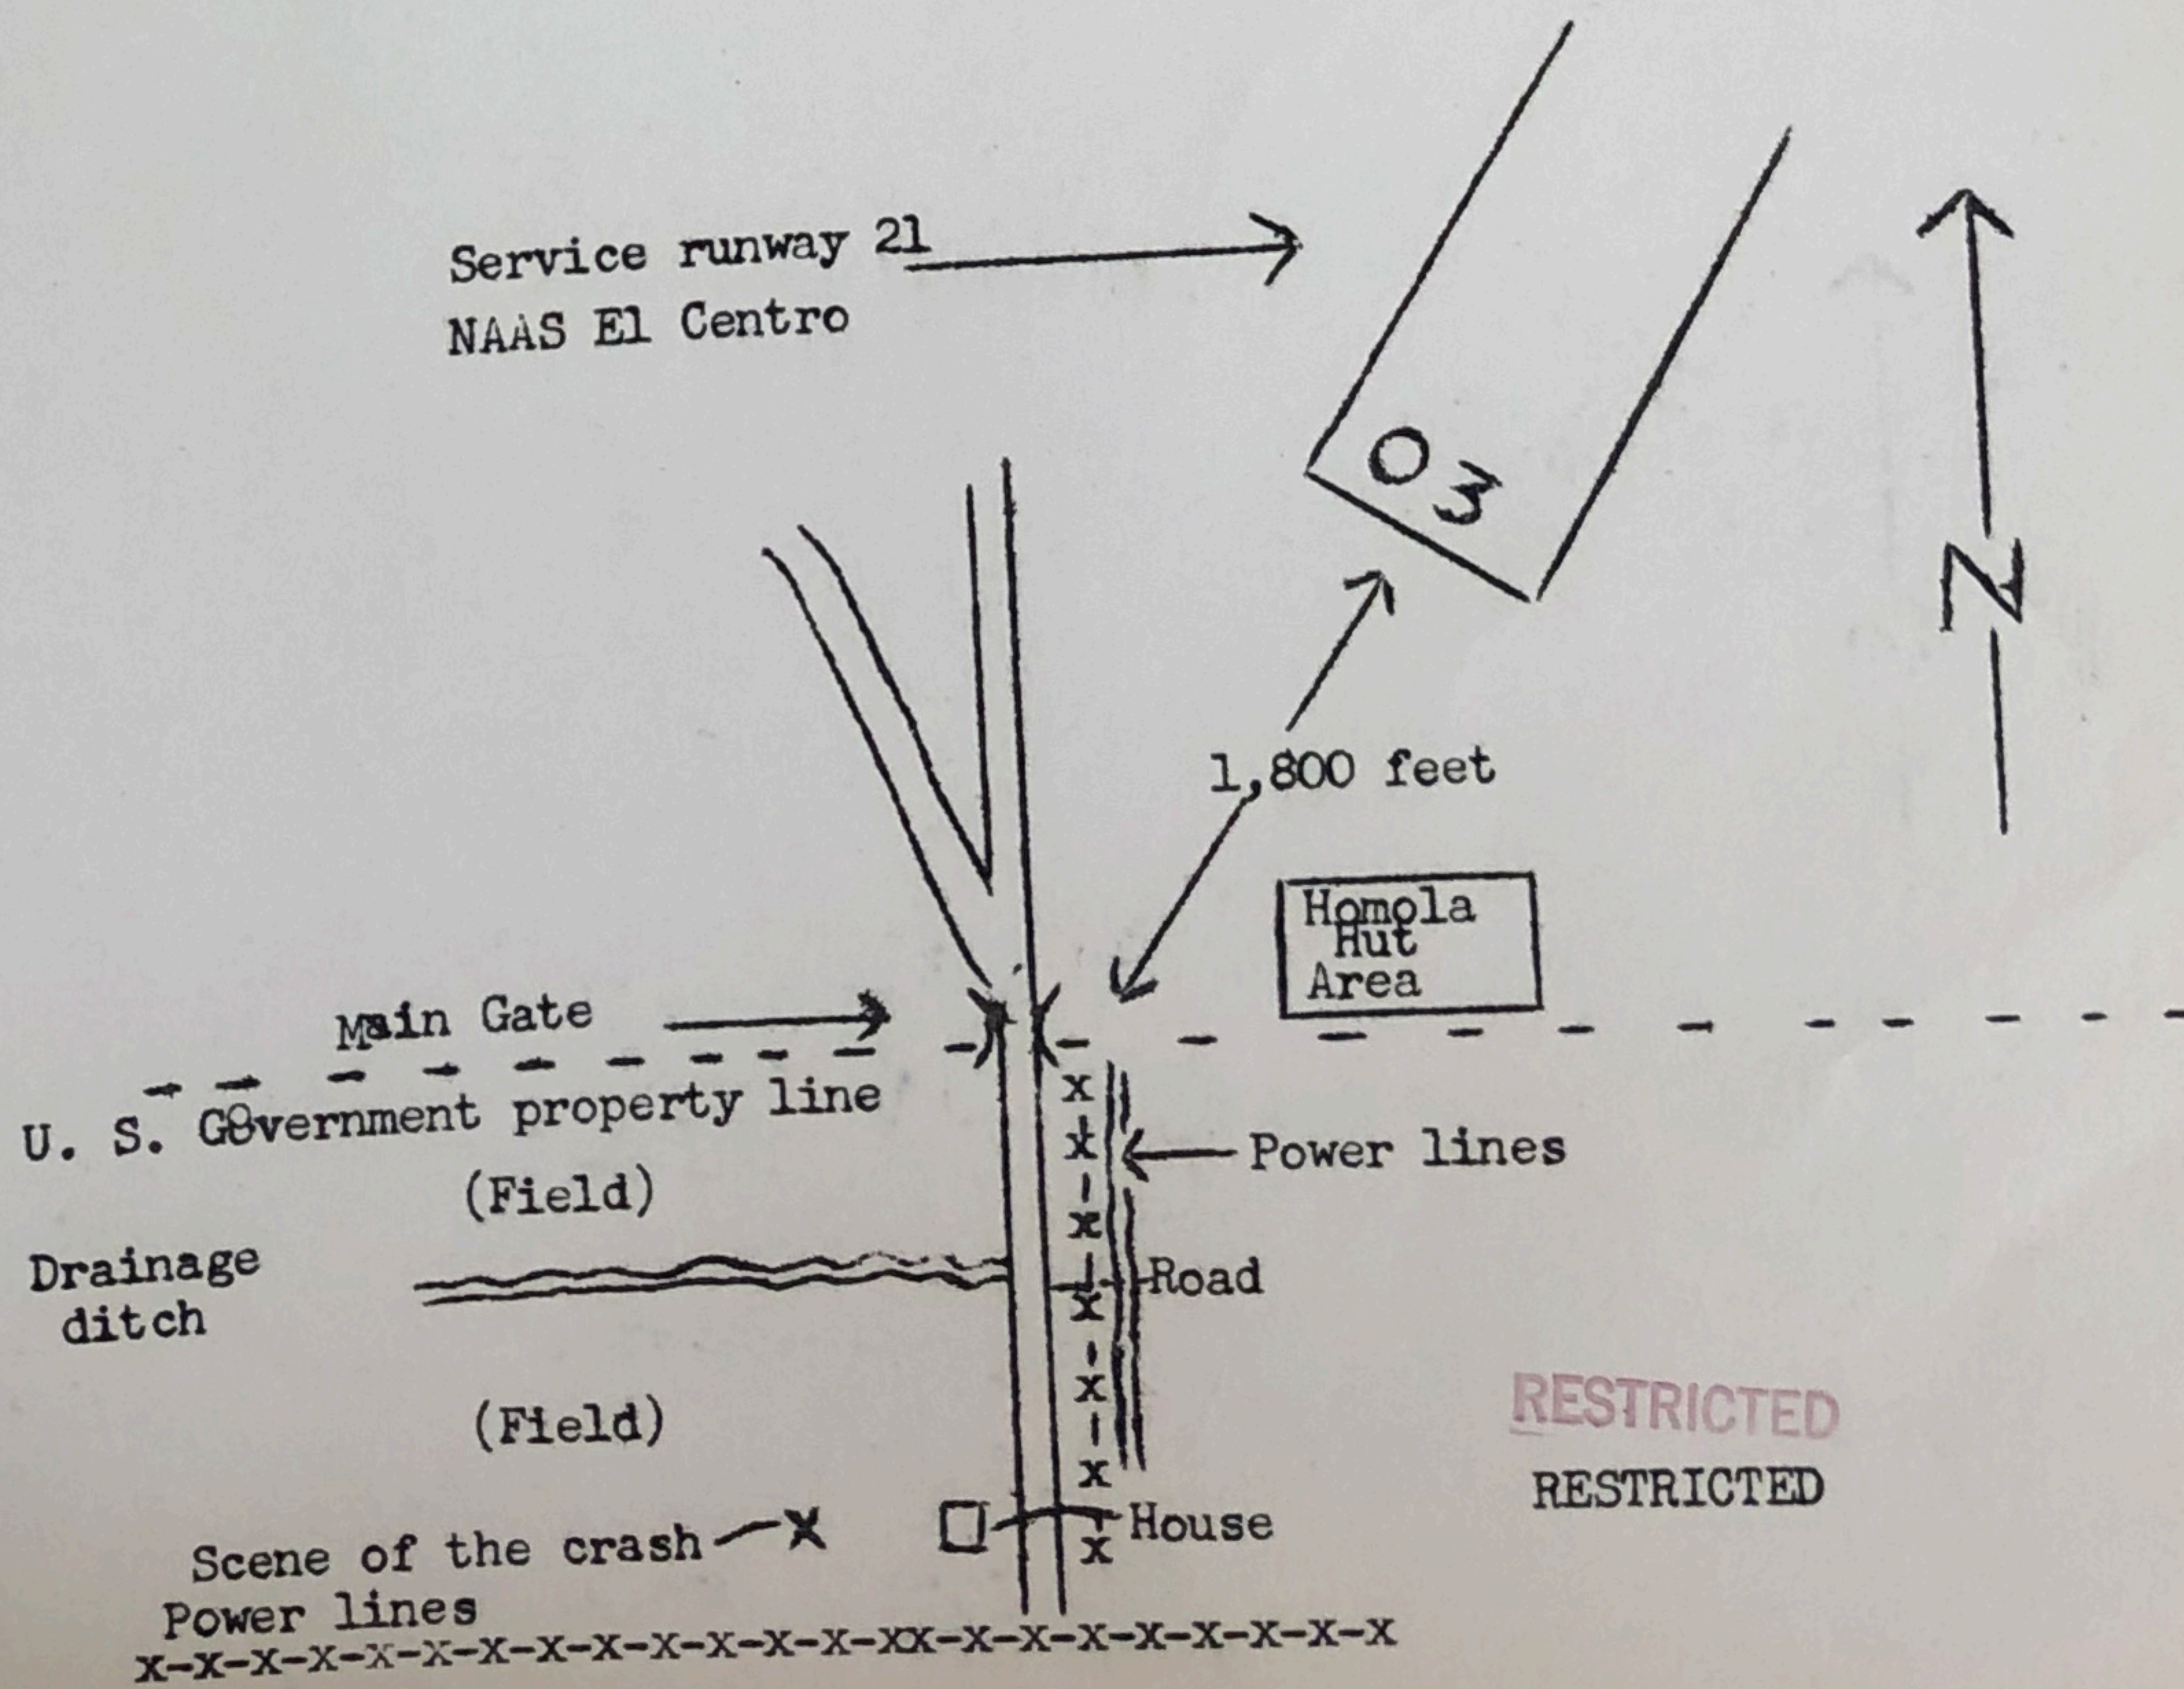
The aircraft suffered strike damage in the accident. The sequence of the damage appeared to be as follows: After engine failure at approximately one hundred and fifty (150) feet, the aircraft made contact with the ground straight ahead in what appeared to be a very nose high, full stalled flight attitude. On initial impact the estimated speed of the aircraft was seventy-five (75) to eighty (80) knots. At this point the fuselage broke in half at the cockpit just forward of the pilots seat and armor plate.

The tail section, with the pilot, then flew through the air making one (1) summersault flip, coming to rest approximately one hundred and fifty (150) feet from the point of initial impact, facing in the opposite direction.

The forward section, with the wings and engine, made one (1) complete flip, coming to rest on the propeller with the left wing broken off at the wing root. The forward part of the fuselage and the aft part of the fuselage were twenty-five (25) feet apart on final rest.

followed by a slight turn to the right. The aircraft was then seen to mush into an open field approximately three fourths (3/4) of a mile from the end of the service runway. The aircraft was then seen to brake in half at station one eight six (186), with the tail section doing a flip over the front section of the aircraft.

The accident board, in its investigation at the scene of the accident, determined that the aircraft traveled one hundred and fifty (150) feet from the point of impact before coming to rest.

The following diagram is submitted as an aid in diagnosing the accident.
